PRELIMINARY ASSESSMENT (PA) REPORT

Fostoria Industries Inc.
Fostoria, Seneca County, Ohio
EPA ID #04N 000 510 314

Preliminary Assessment Report Fostoria Industries Inc.

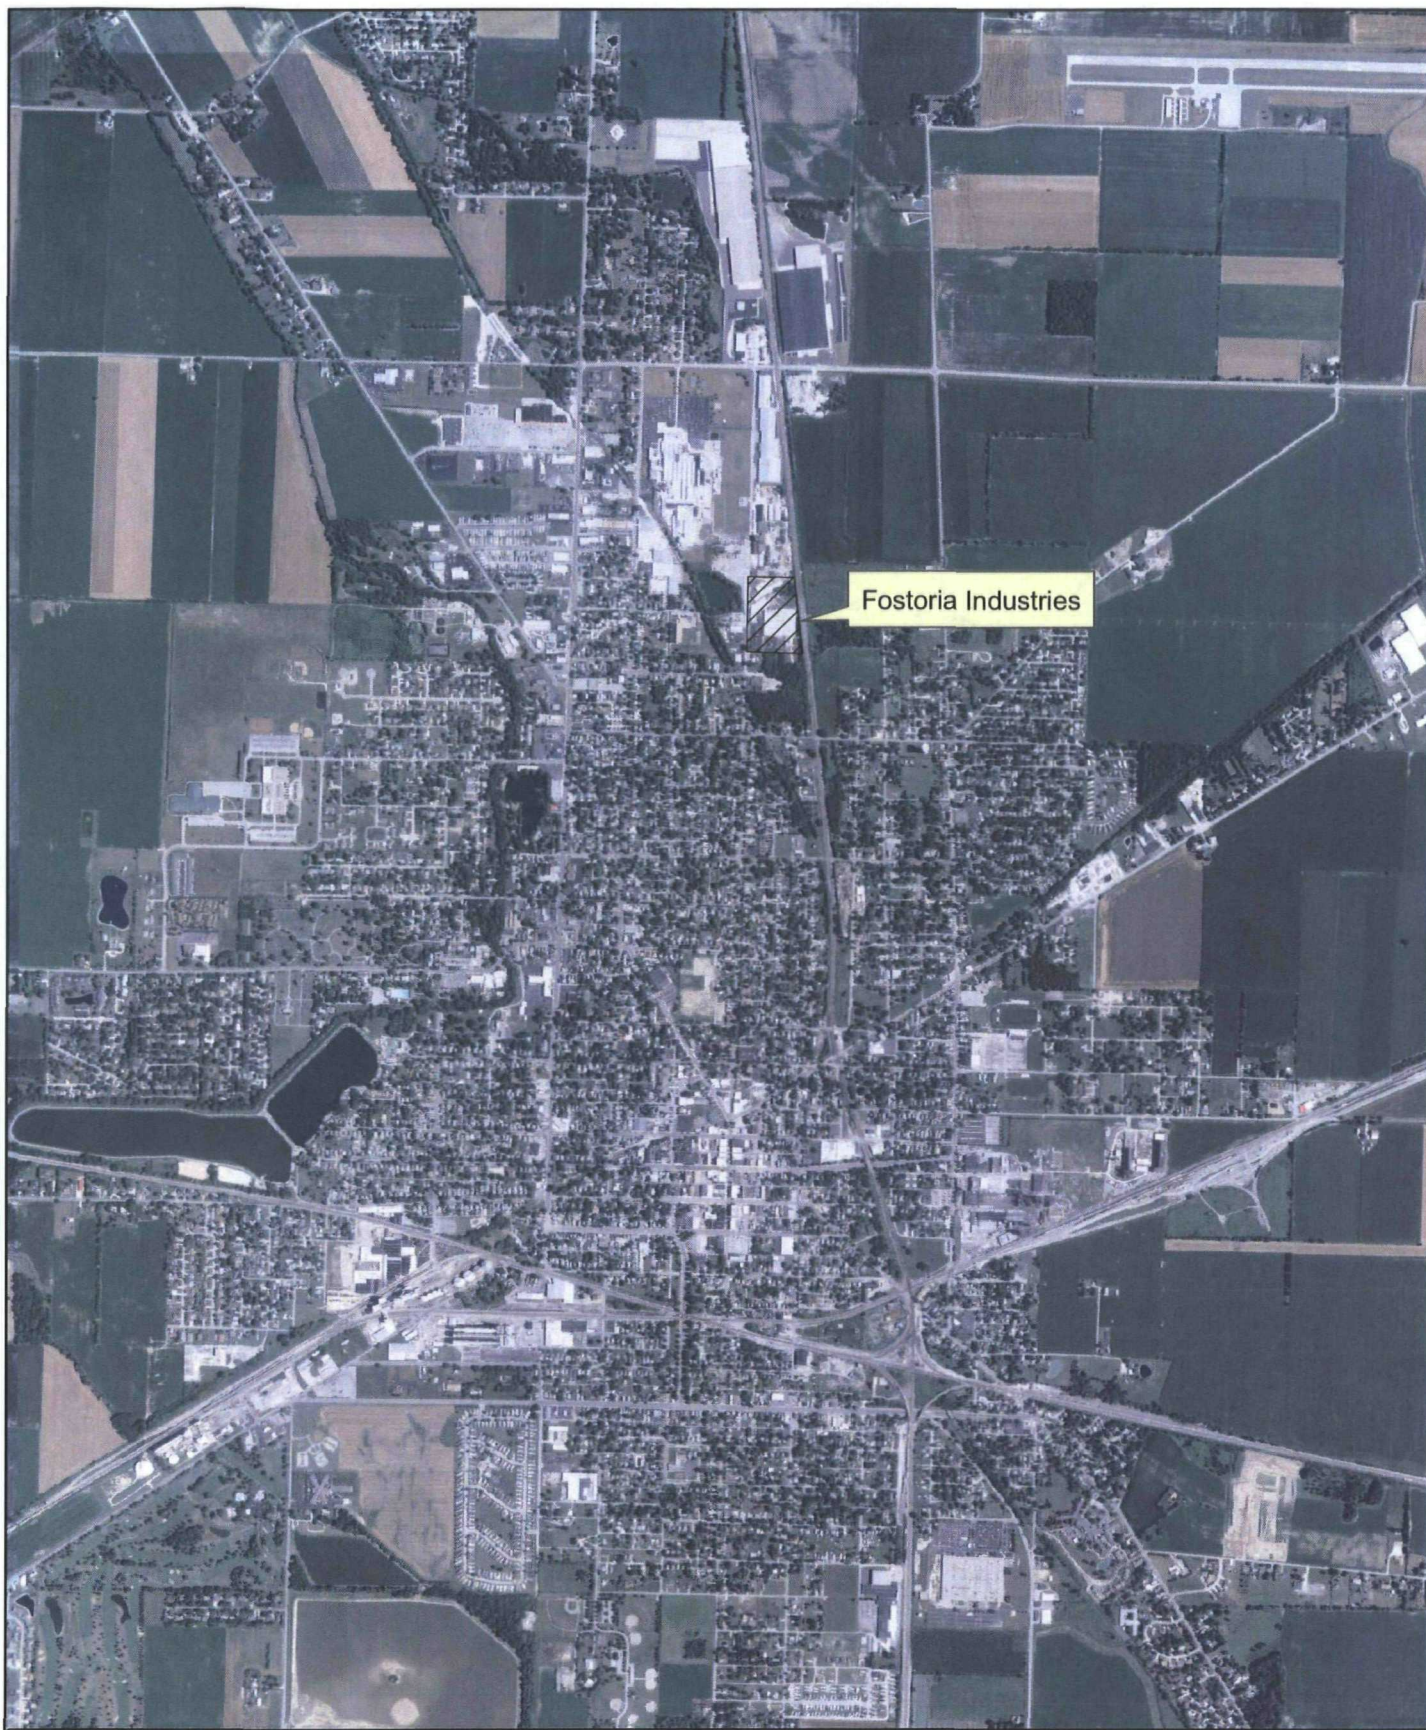
FIGURE 2: AERIAL PHOTOGRAPH

FOSTORIA INDUSTRIES
FOSTORIA, SENECA COUNTY, OHIO
2005 AERIAL PHOTOGRAPH

Fostoria Industries is an active manufacturing facility located at 1200 North Main Street in Fostoria, Seneca County, Ohio. (Figures 1 & 2). The site is located in an industrial and residential area of northern Fostoria. The site is bordered to the west by North Main, to the east by Railroad tracks, to the north by the Former Chrysler Foundry, and to the south by residential and commercial/industrial areas.
